Manhole Inspection Summary

Manhole # S23KK_055MH

Insp Date: **8/27/07 10:39 AM**

Location Address: **1216 WHITELOCK ST**

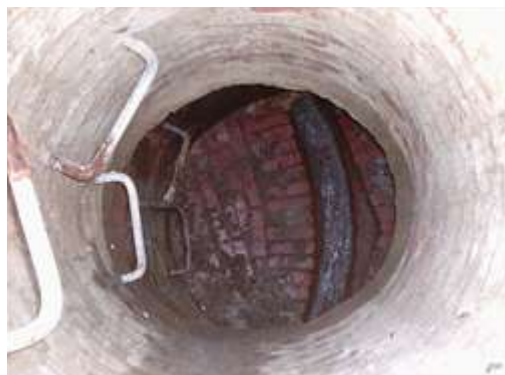
Top View

Barrel infiltration. Corroded steps.
Evidence of surcharge - Bench debris.

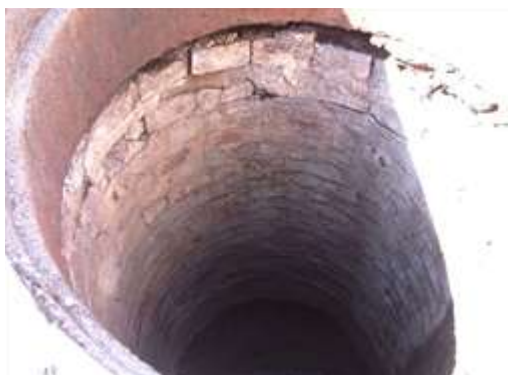
Defect

Adjustment deterioration, loose brick and
infiltration - other side.

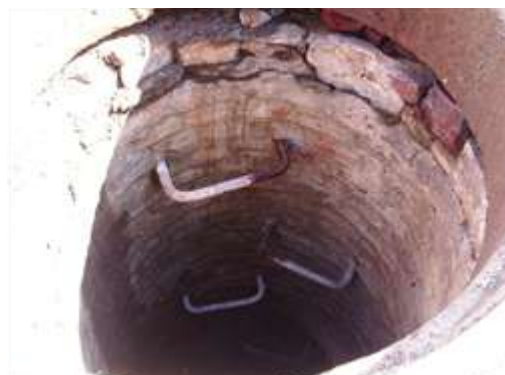
Defect

Adjustment deterioration, loose brick and
infiltration.

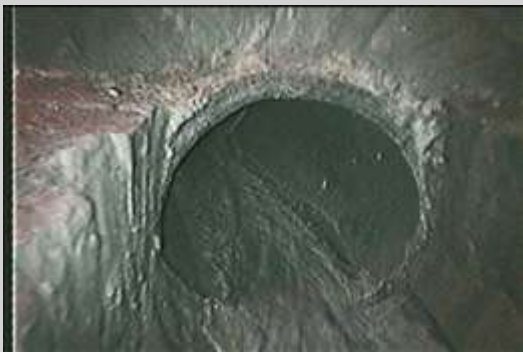
8 in. Circular Gravity Sewer Pipe Out @ 12 O'Clock

Infiltration: **Evidence** Pipe Seal Cond: **Unknown**

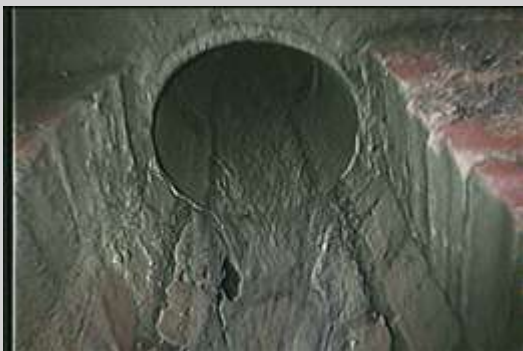
8 in. Circular Gravity Sewer Pipe In @ 6 O'Clock

Infiltration: **None** Pipe Seal Cond: **Unknown**
